**Phase I Environmental Site Assessment for  
Carolina Club  
3011 N Rock Island Road, Margate, FL**

Prepared for:  
**Rosemurgy Acquisitions, LLC**

**WGI Project No. 10469.00**

**Report Issuance Date: March 21, 2024**  
**Report Expiration Date: August 27, 2024**

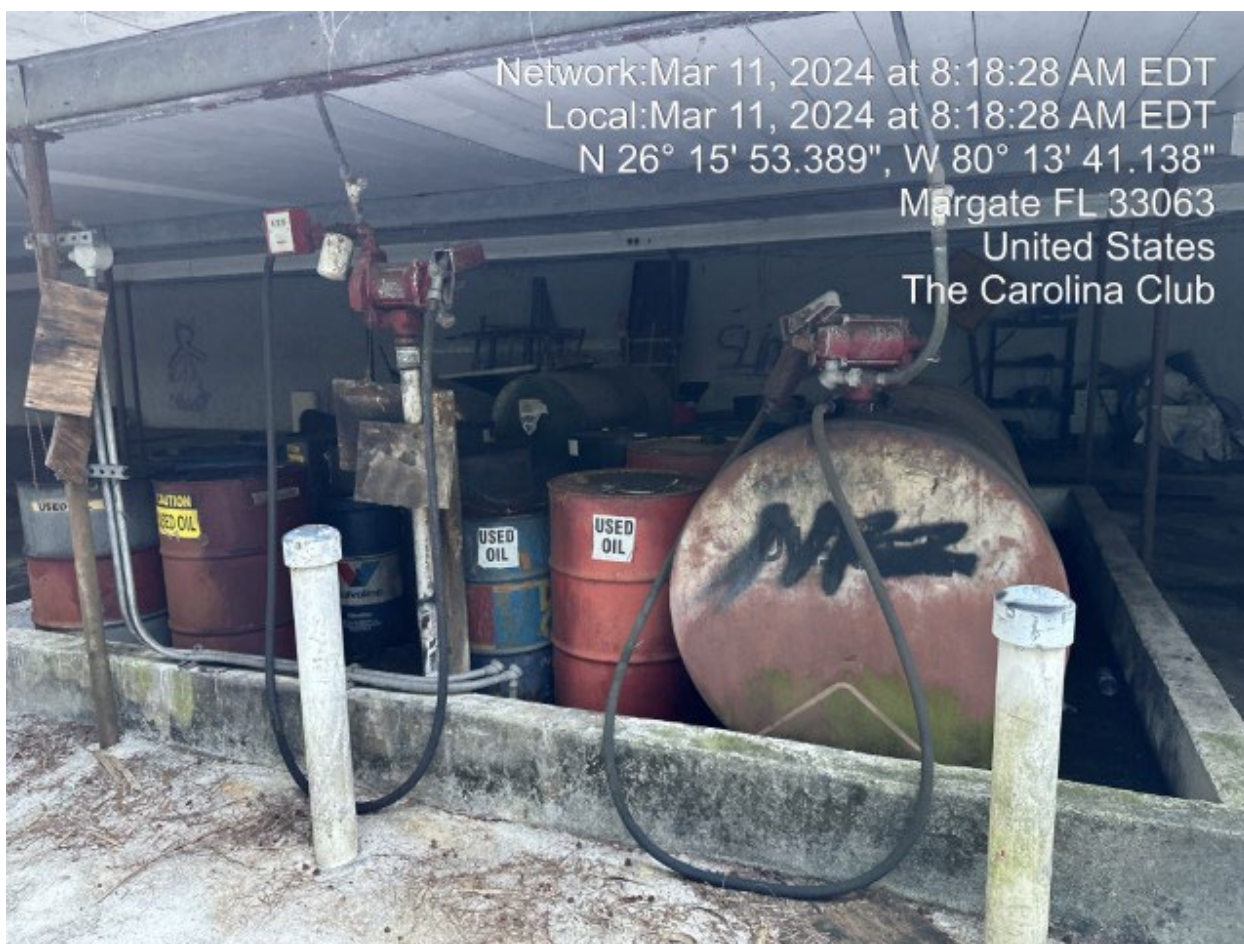
- There are several 55-gallon drums of hazardous substances or petroleum products, primarily or entirely waste oil, at the maintenance building next to the AST and UST. WGI found no evidence of a significant release from these containers.

| Photo Number: 5 | AST and drum storage area - on the north side of the maintenance building - under a roof. Diesel AST at right. Drums of waste oil and oily rags. Behind the diesel AST is a waste oil AST and some other ASTs which appear to be inactive and empty. ASTs and the majority of the oil drums are within a concrete secondary containment wall. Heavy staining inside the containment wall, but no evidence of a release through or over the containment wall. Gasoline UST is under the concrete pad in the foreground (not evident in this photo). |

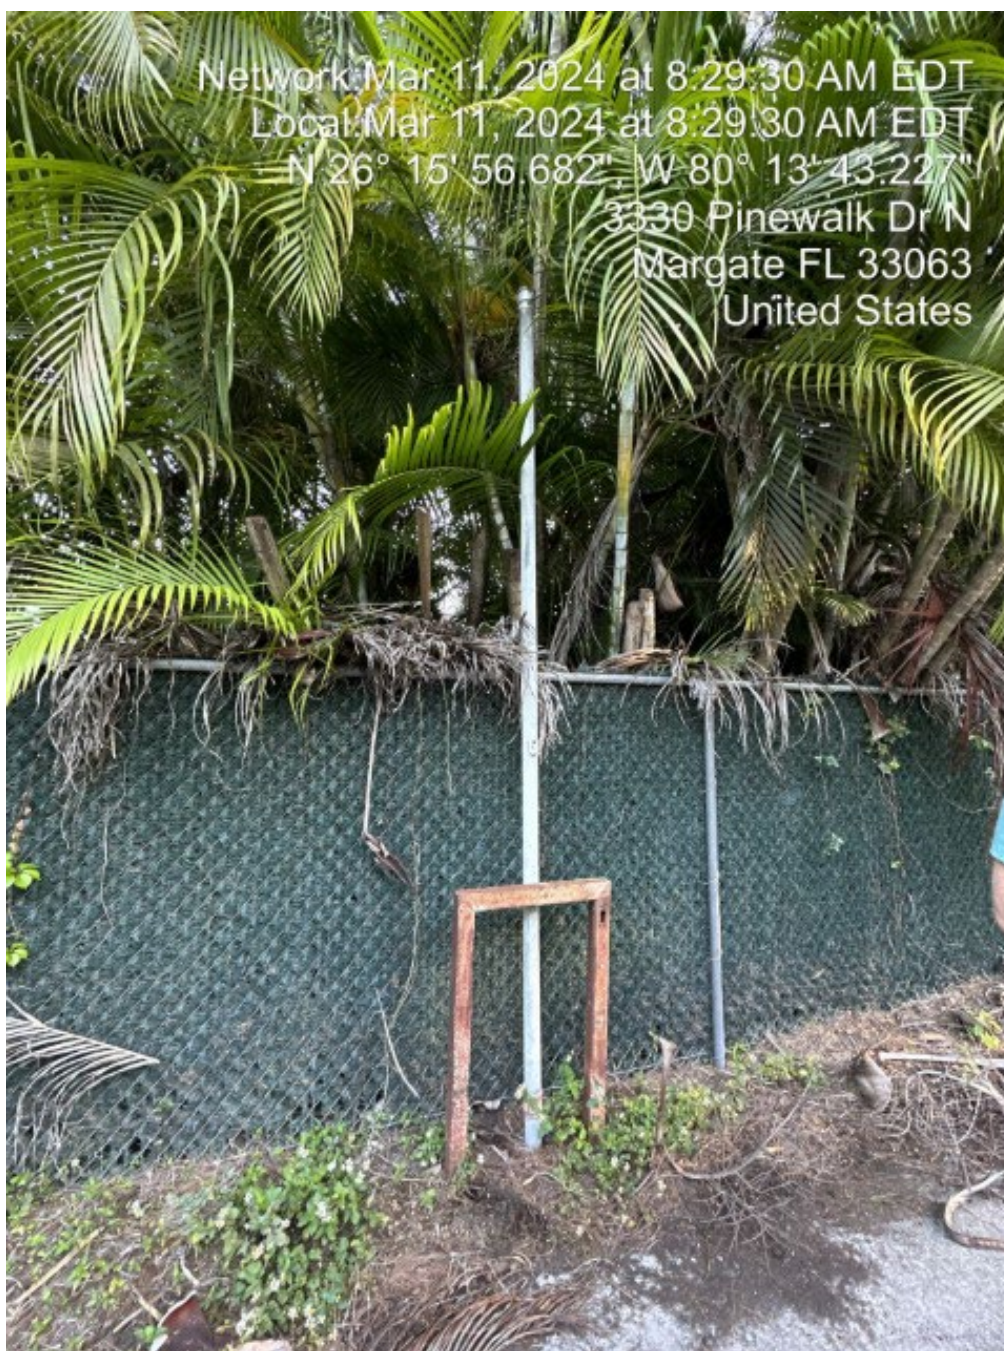
| Photo Number: 10 | Vent pipe for the gasoline UST. North of the maintenance building next to the AST and drum storage area. |

- Tank #4 (Remains): Broward County records indicate there is a 600 gallon underground storage tank (UST) for gasoline located at the site; Broward County records indicate it was installed in December 1992 and is a double-wall fiberglass tank. It remains in service. The UST is periodically inspected by FDEP; the most recent UST inspection was on 3/3/2023; that inspection revealed several violations related to spill bucket corrosion, inadequate annual release detection and integrity testing, and similar issues. The UST is on the north side of the maintenance building.
