**PHASE I ENVIRONMENTAL SITE ASSESSMENT
ALL APPROPRIATE INQUIRY**

**Commercial Property
Heron Bay Golf Course – Four (4) Parcels
Heron Bay Boulevard, Heron Run Drive, and Nob Hill Road
Coral Springs, Broward County, Florida 33076**

**Environmental Risk Management
ERMI File No.: E4590A
August 19, 2022**

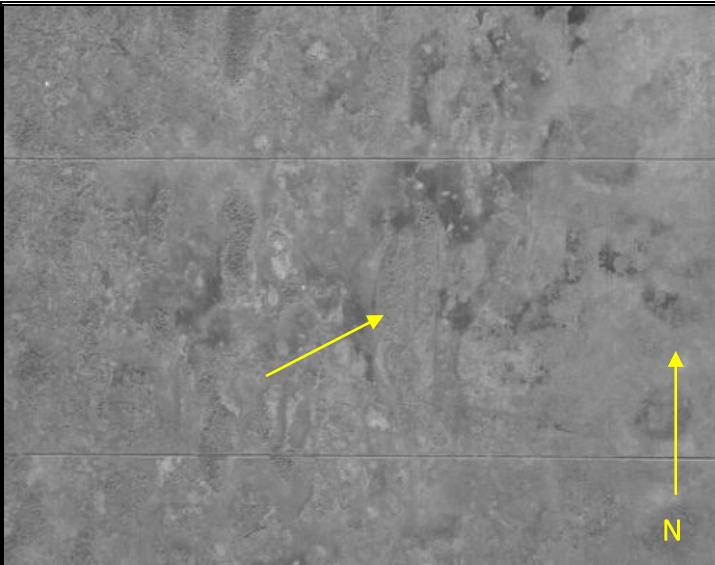
1958	Agricultural land use is observed on the Subject and adjoining properties.

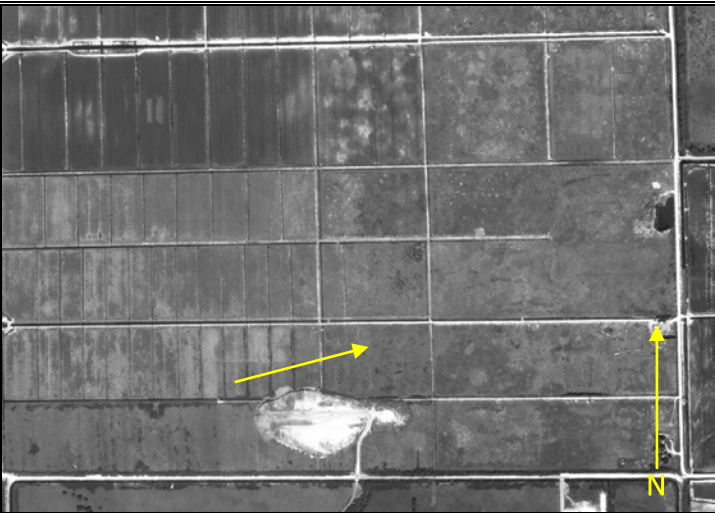
1988	Agricultural land use is observed on the Subject and adjoining properties. Land clearing is observed on the southern portion of the Subject Property.

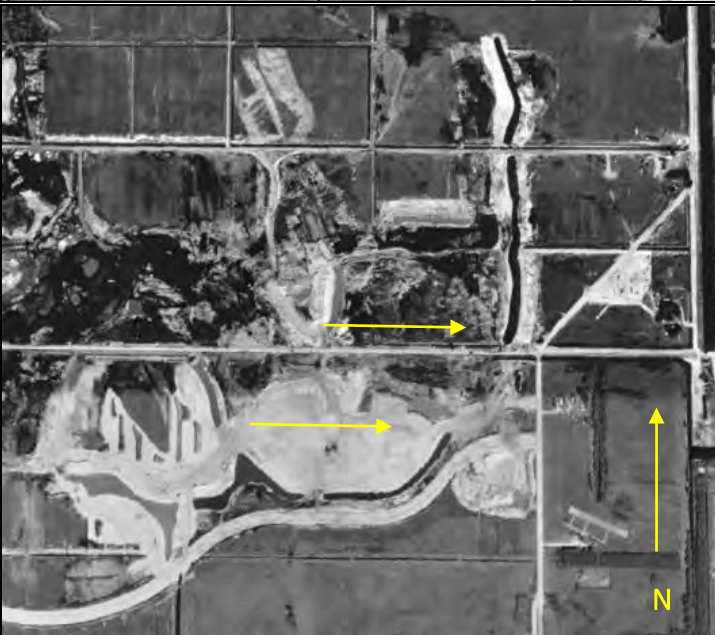
1995	Agricultural land use is no longer observed on the Subject Property. Land clearing is observed on the Subject and adjoining properties in preparation for future development of a golf course and residential dwellings. The beginning development of retention ponds are observed on the adjoining properties. Agricultural land use is

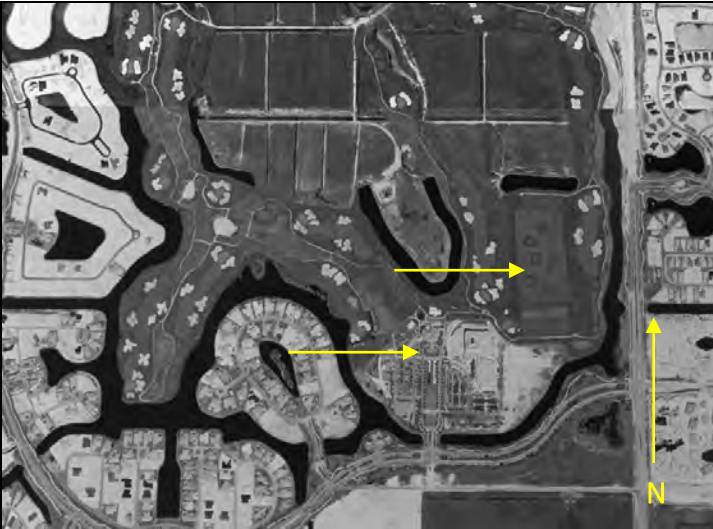
observed on the north and south adjoining properties.	
1999	<p>A commercial structure, paved parking lot, shed structure, and golf course have been developed on the Subject Property.</p> <p>Retention ponds have been developed on the adjoining properties.</p> <p>The south adjoining commercial structures have been developed.</p> <p>Residential development is observed on the west and east adjoining properties. Agricultural land use is observed on the north adjoining property.</p>

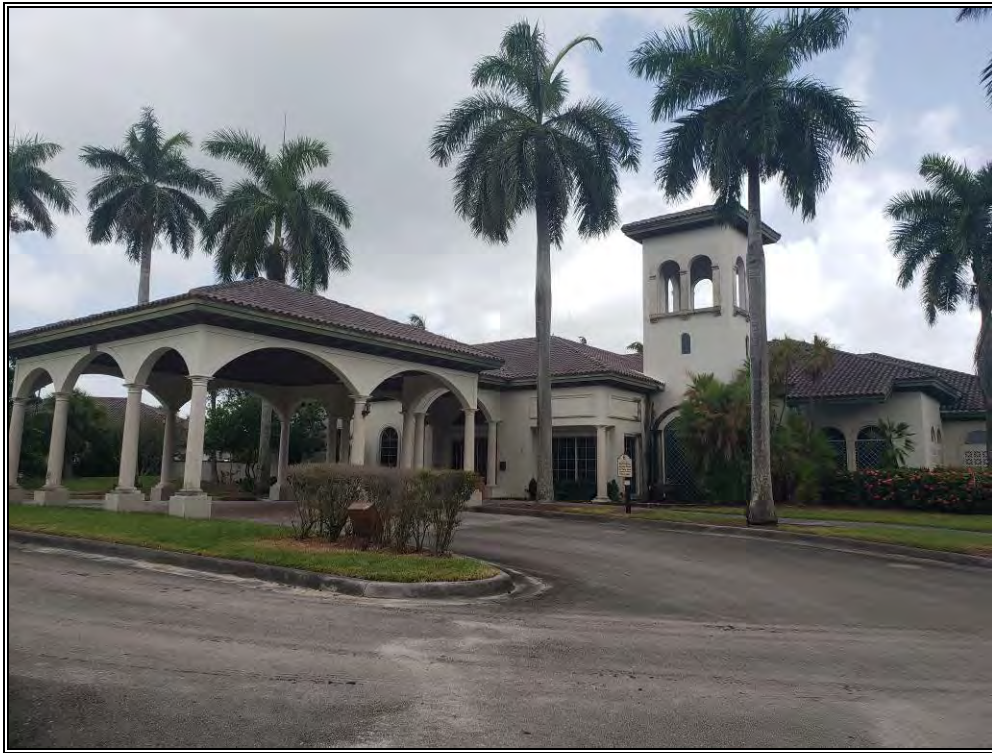
Above: A representative view of the commercial structure on the fourth parcel of the Subject Property (Parcel ID No. 4841 06 01 0010) observed during the site reconnaissance.

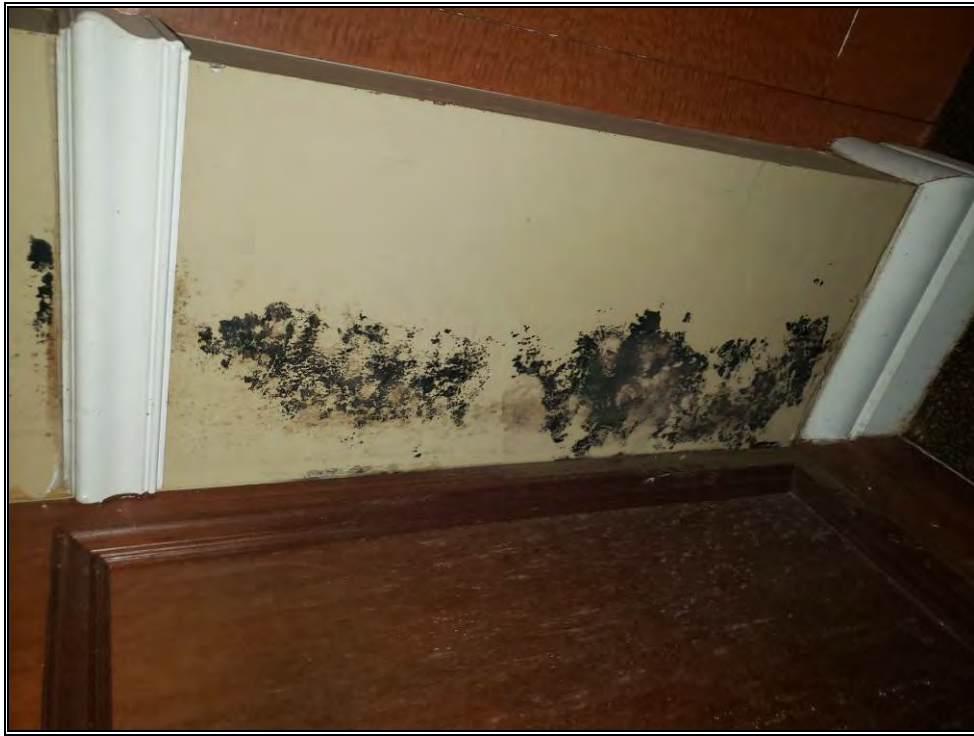
Above: A representative view of mold in the interior of the commercial structure on the fourth parcel of the Subject Property observed during the site reconnaissance.

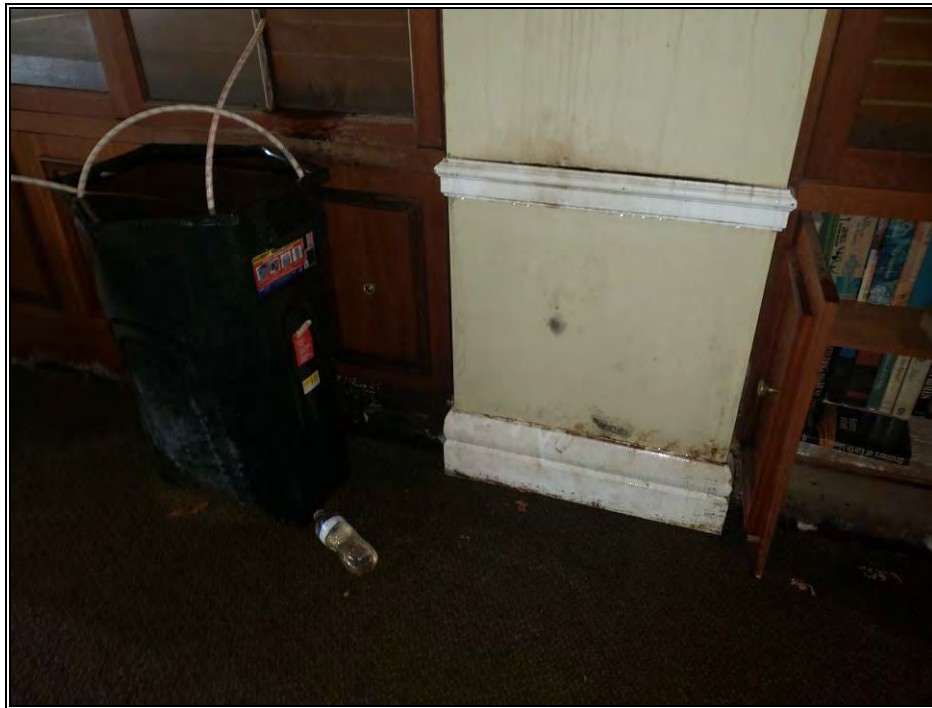
Above: A representative view of mold and water damage in the interior of the commercial structure on the fourth parcel of the Subject Property observed during the site reconnaissance.

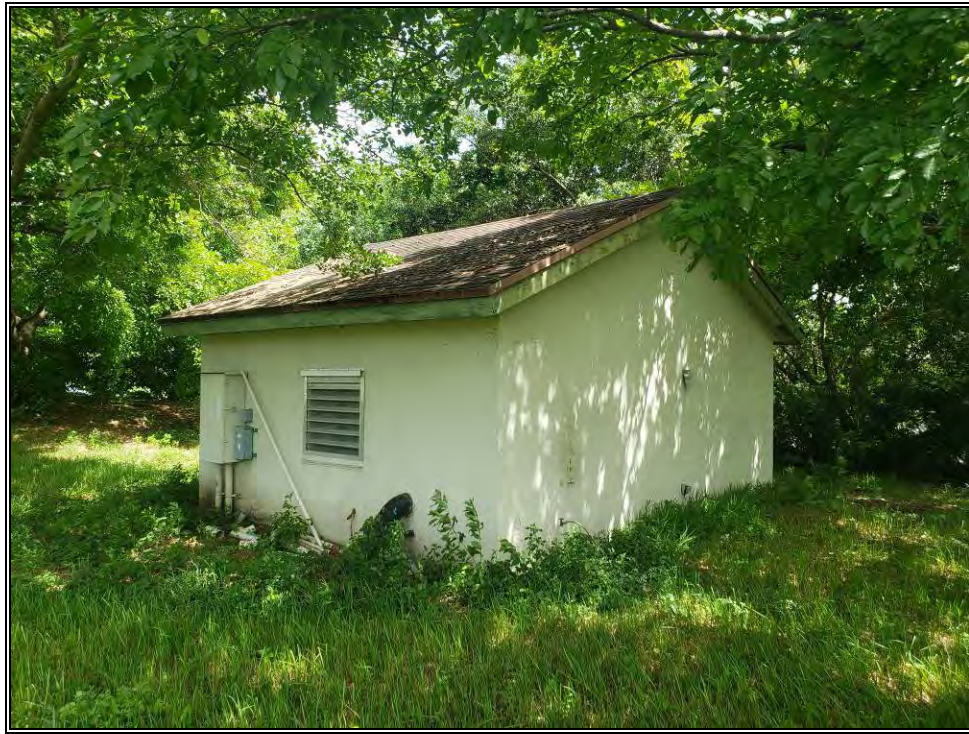
Above: A representative view of the shed structure on the second parcel of the Subject Property (Parcel ID No. 4841 05 01 0134) observed during the site reconnaissance.

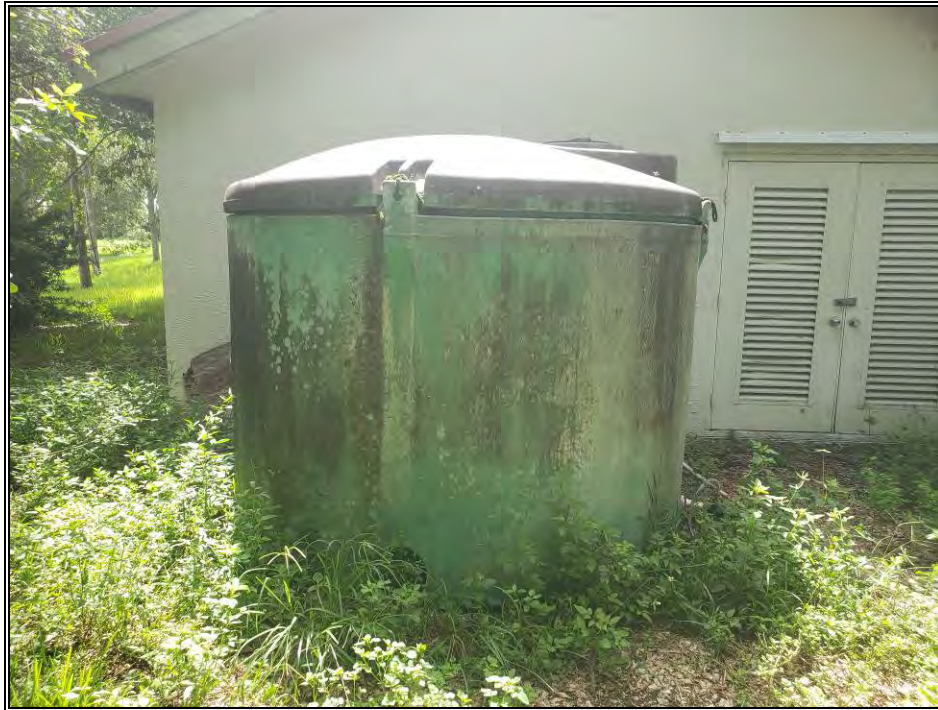
Above: A representative view of the one (1) approximately 1,000-gallon high-density polyethylene (HDPE) aboveground storage tank (AST) containing liquid fertilizer on the second parcel of the Subject Property observed during the site reconnaissance.

One (1) approximately 1,000-gallon high-density polyethylene (HDPE) aboveground storage tank (AST) was observed on the Subject Property during the site reconnaissance. The AST was located on the second parcel of the Subject Property near a shed structure. According to Ms. Jane Early, a representative of the current owner of the Subject Property, the contents of the AST included liquid fertilizer hooked up to the irrigation well in the shed structure and were utilized for the former golf course on the Subject Property. The irrigation well is reportedly no longer in use. The AST was not properly labeled with its contents and was not stored in proper secondary containment. The AST was stored over an unpaved, pervious surface with no surrounding staining. Because the AST is no longer utilized for the golf course on the Subject Property, ERMI recommends properly disposing of the AST at a permitted facility. Due to the lack of visible staining in the soil surrounding the AST, the AST is not considered to represent an environmental concern to the Subject Property.

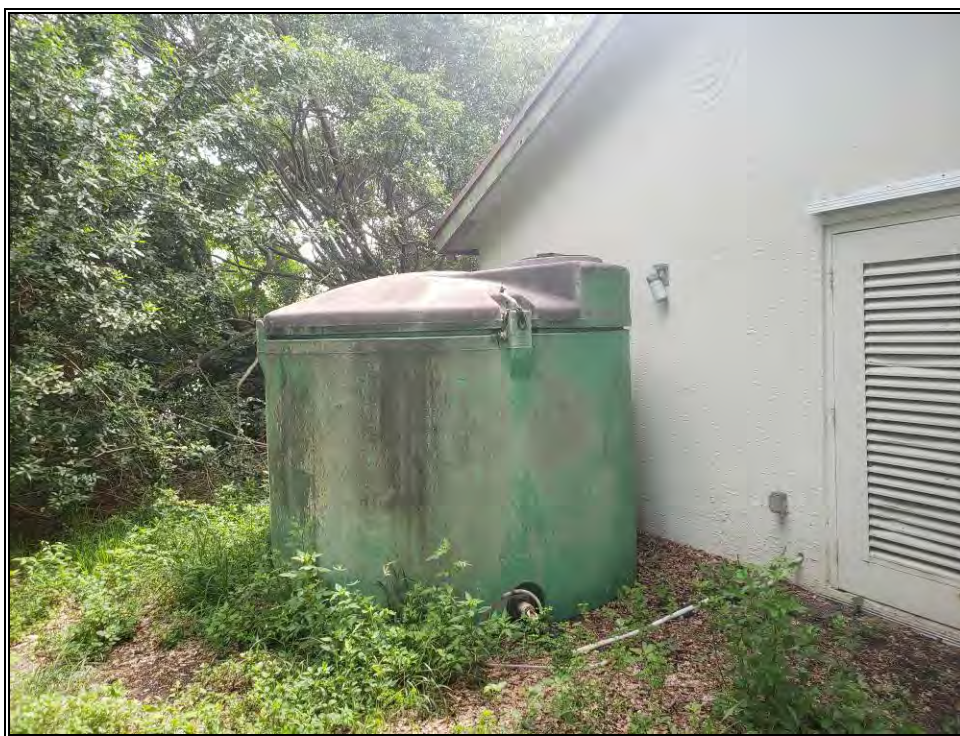
Above: A representative view of the one (1) approximately 1,000-gallon HDPE AST containing liquid fertilizer on the second parcel of the Subject Property observed during the site reconnaissance.

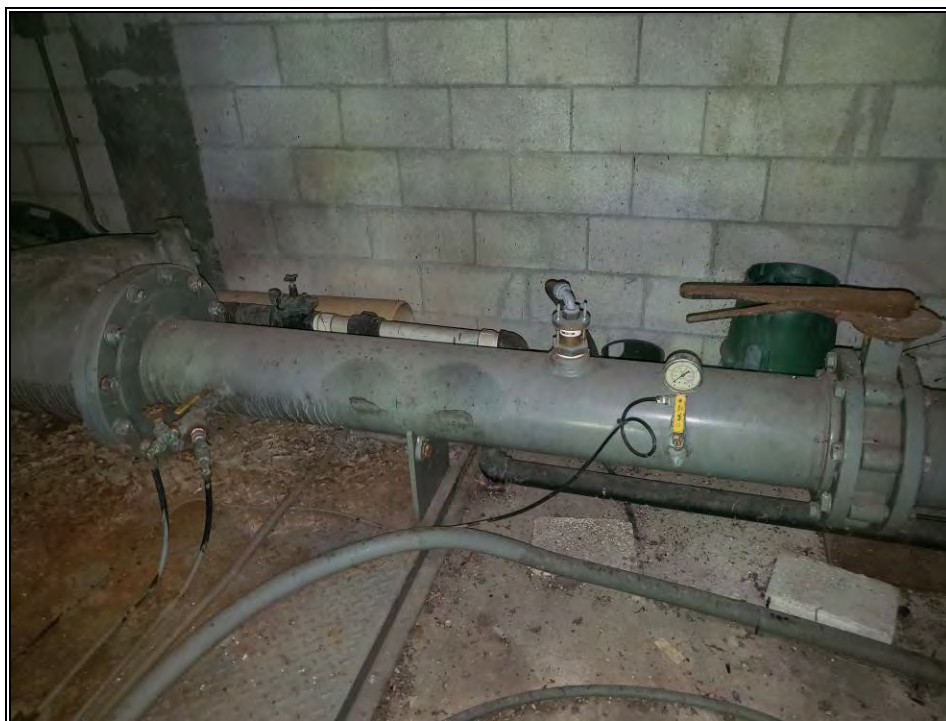
Above: A representative view of the irrigation well in the shed structure on the second parcel of the Subject Property observed during the site reconnaissance.

One (1) irrigation well was observed on the Subject Property. An additional irrigation well is identified on the Environmental Database Report (EDR) that was included in the original boundary of the Subject Property; however, the boundaries of the Subject Property changed after the EDR was ordered. The second irrigation well is not included on the Subject Property. The one (1) irrigation well was observed in a shed structure on the second parcel of the Subject Property during the site reconnaissance. According to Ms. Jane Early, a representative of the owner of the Subject Property, the irrigation well is no longer in use and was previously utilized to provide fertilizer to the former golf course on the Subject Property. The fertilizer was stored in an approximately 1,000-gallon HDPE AST that is located outside of the shed structure. The irrigation well appeared to be in poor condition during the site reconnaissance. Ms. Early stated that the North Springs Improvement District (property owner) has plans to remove the irrigation well from the Subject Property.

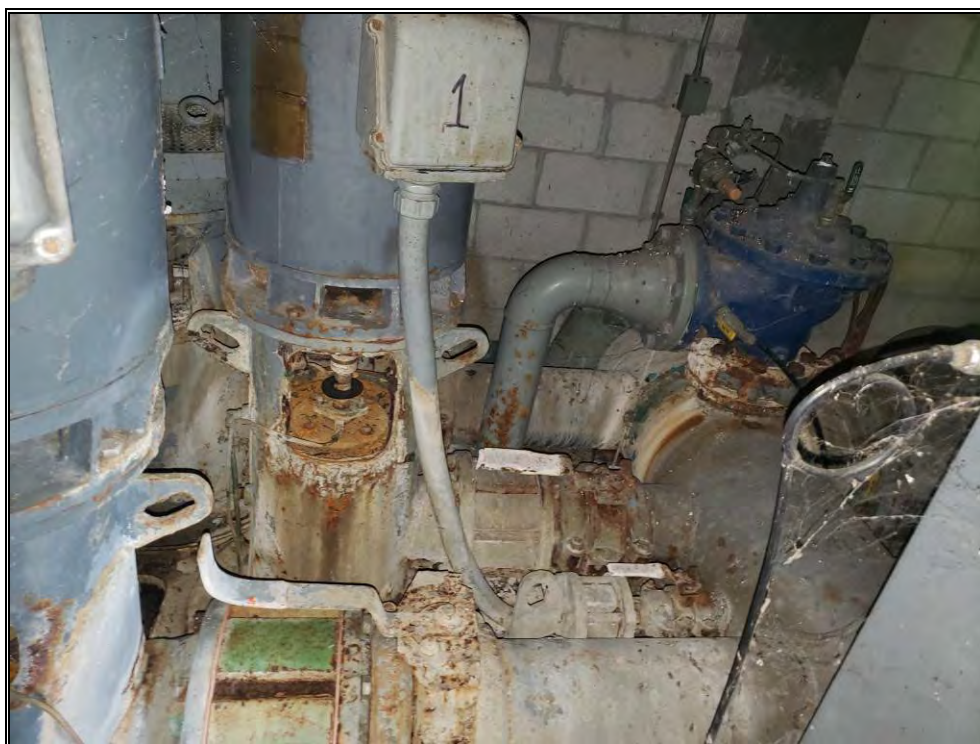
Above: A representative view of the irrigation well in the shed structure on the second parcel of the Subject Property observed during the site reconnaissance.

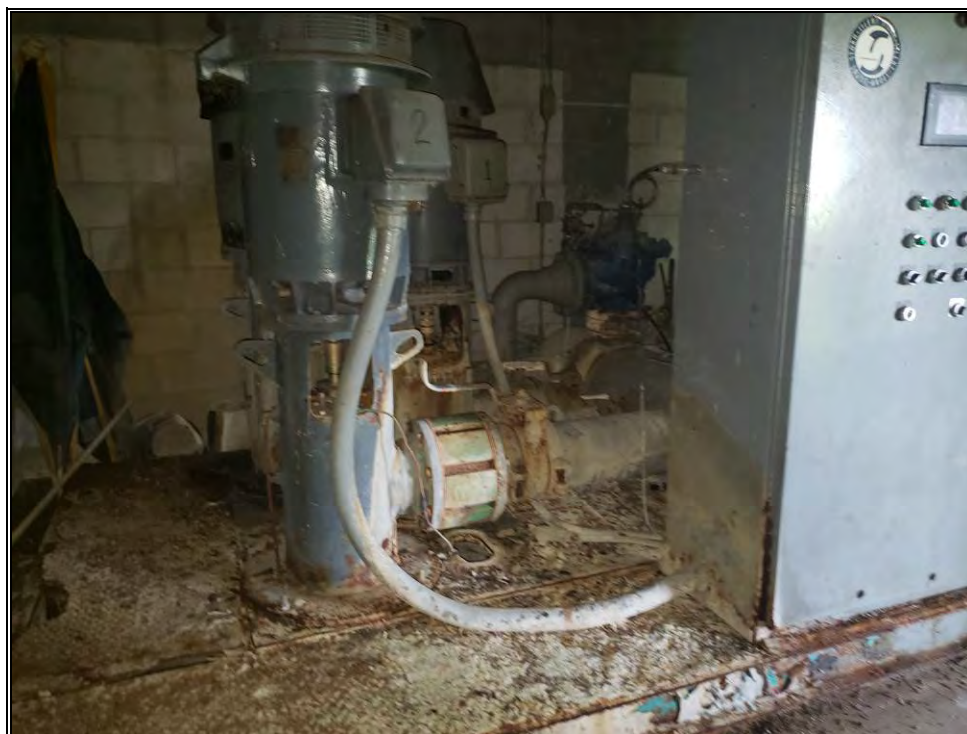
Above: A representative view of the irrigation well in the shed structure on the second parcel of the Subject Property observed during the site reconnaissance.

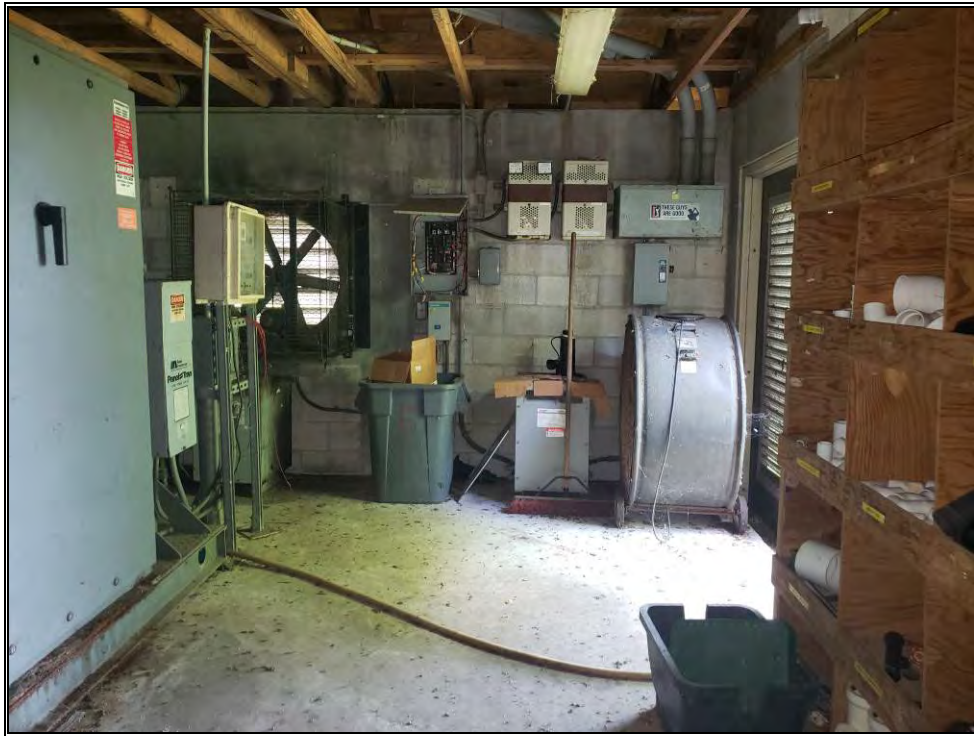
Above: A representative view of the interior of the shed structure on the second parcel of the Subject Property observed during the site reconnaissance.

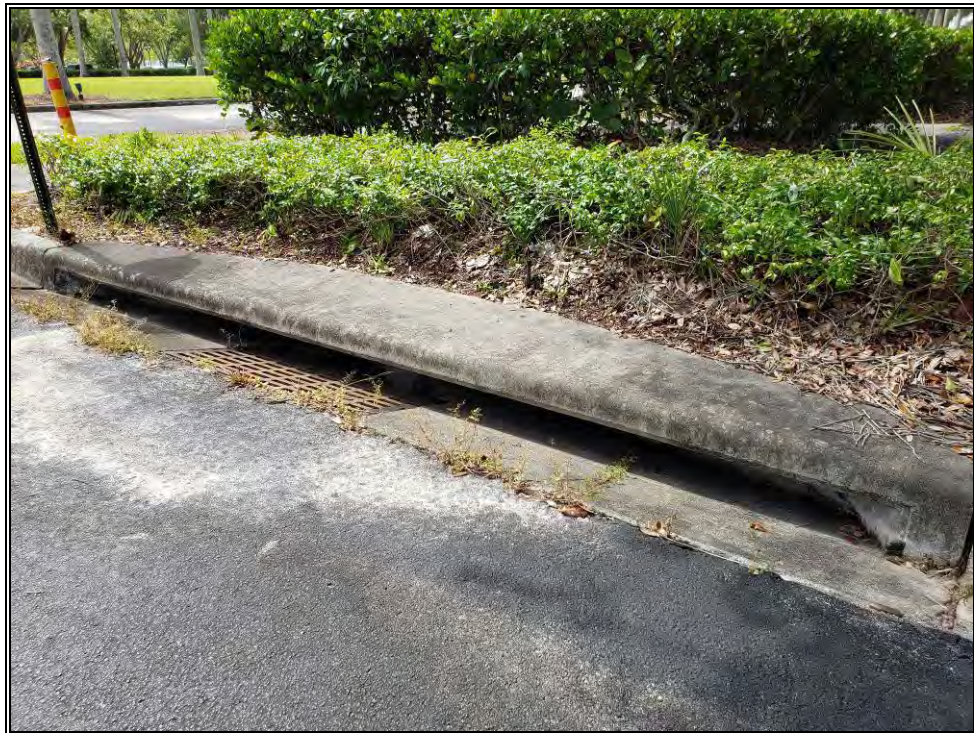
Above: A representative view of a stormwater drain on the Subject Property observed during the site reconnaissance.

Stormwater drains were observed on the paved parking lot of the fourth parcel of the Subject Property during the site reconnaissance. Stormwater drains collect rainwater and runoff and are not considered to represent an environmental concern to the Subject Property.

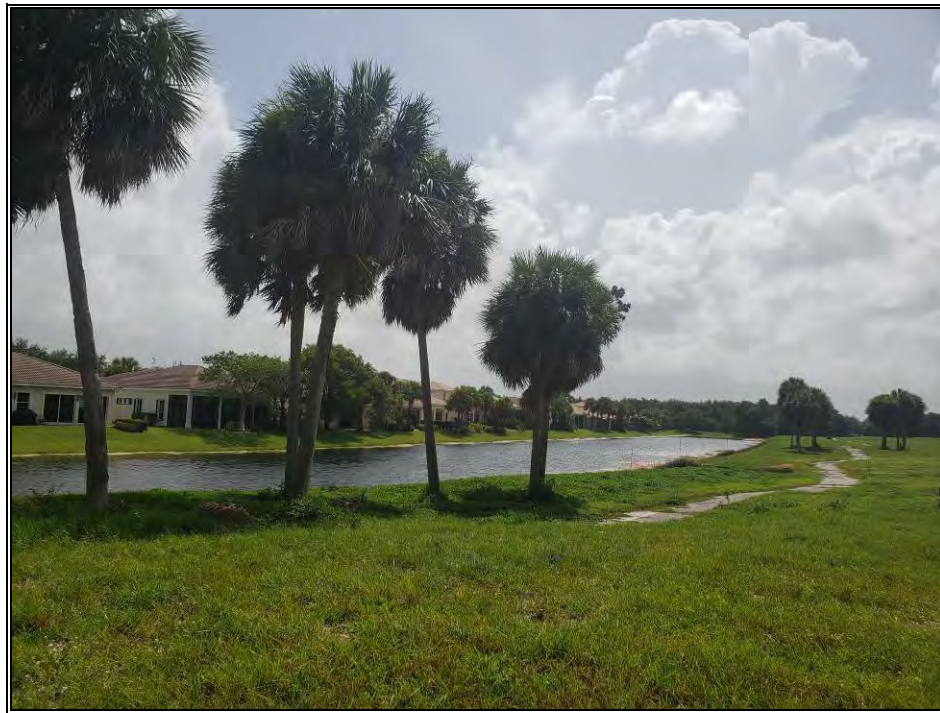
Above: A representative view of the former golf course land on the Subject Property and the adjoining retention pond and residential dwellings observed during the site reconnaissance.

No pits, ponds, or lagoons were observed on the Subject Property during the site reconnaissance. Several retention ponds were observed on the adjoining properties during the site reconnaissance. No oily sheen was observed on the surface of the adjoining retention ponds that would indicate the presence of hazardous substances or petroleum products. The retention ponds collect rainwater and runoff and are not considered to represent an environmental concern to the Subject Property.

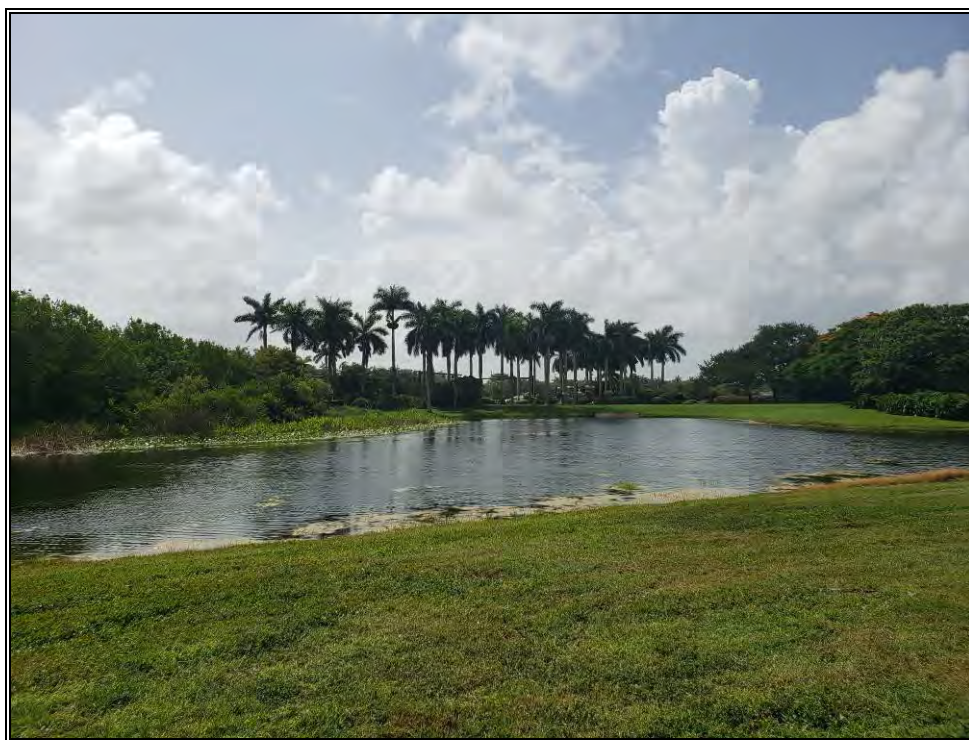
Above: A representative view of the adjoining retention pond observed during the site reconnaissance.

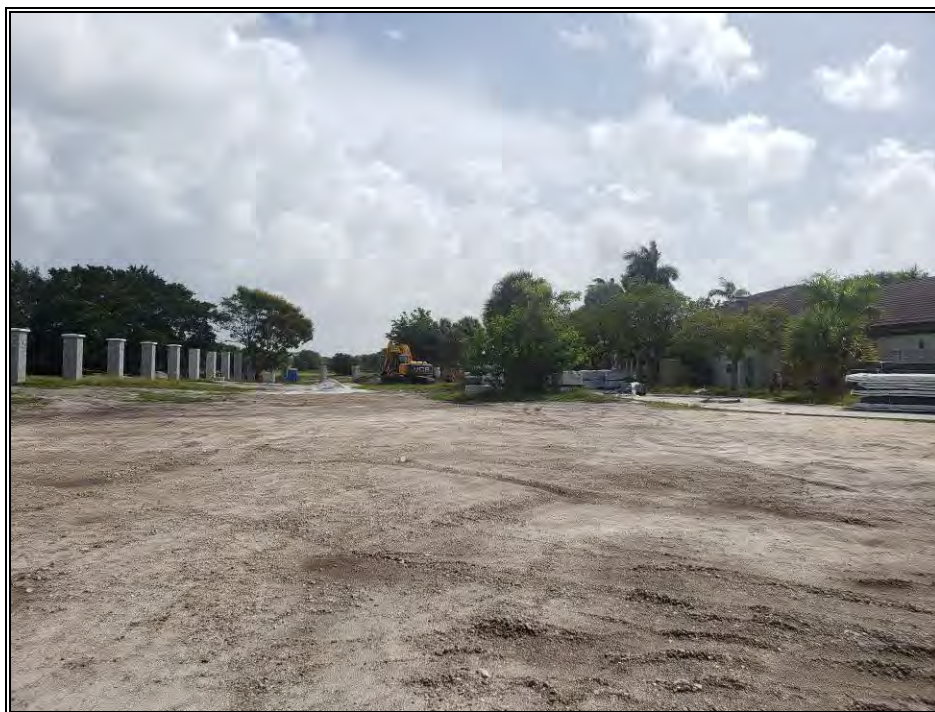
Above: A representative view of the active construction area on the west adjoining property observed during the site reconnaissance.
